# Bone-level Zirconia Implant Fracture in a Nickel-allergic Patient: a case report.

**Citation:** Munoz S, Shapiro S, Owens WH, Redmond DL, and Johnson TM. (2025) Bone-level Zirconia Implant Fracture in a Nickel-allergic Patient: a case report. J Dent Oral Epidemiol 5(3): doi <https://doi.org/10.54289/JDOE2500111>

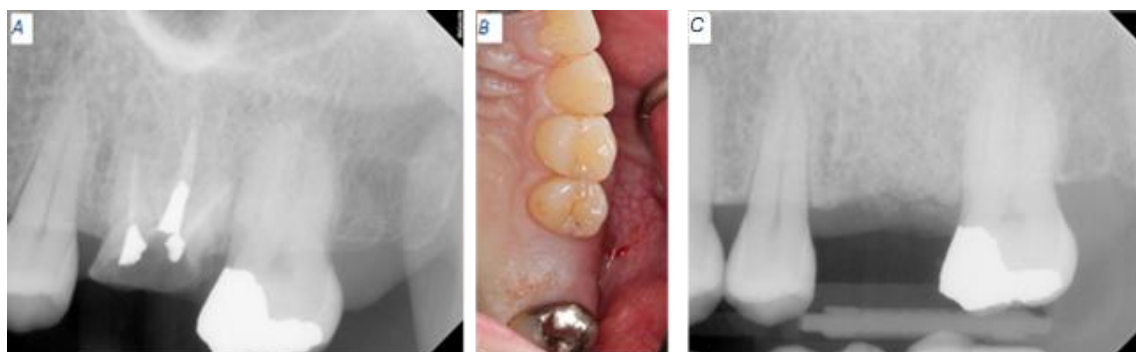
**Figure 1:** Baseline radiographic clinical appearance for site #14. (A) Catastrophic tooth fracture. (B) Four months after extraction of tooth #14. (C) Remaining allograft present at the extraction site.

tooth on the upper left and I would like an implant for that gap." Her medical history is significant for gastroesophageal reflux disease (GERD), exercise-induced asthma (EIA), and perennial allergic rhinitis (PAR). She takes cetirizine, pantoprazole, and montelukast every day, but levalbuterol as needed. Review of her medical chart confirms allergies to nickel, lanolin, and sulfa drugs. Nickel and lanolin allergies were diagnosed using a skin patch test. During her initial evaluation, she made it clear that she has irrational dental anxiety and worse yet, surgical phobia. She has a Mallampati class 4 airway. She has been diagnosed with nocturnal bruxism and wears a maxillary hard night guard to mitigate occlusal wear. The tooth on the maxillary left side is missing because it fractured below the alveolar crest and the oral surgeon had to take the patient to the OR to extract tooth #14 and performed an alveolar ridge preservation (ARP). In addition to the ARP, the oral surgeon performed a left lateral window maxillary sinus floor augmentation (LWSA) due to sinus pneumatization (**Fig 1**).

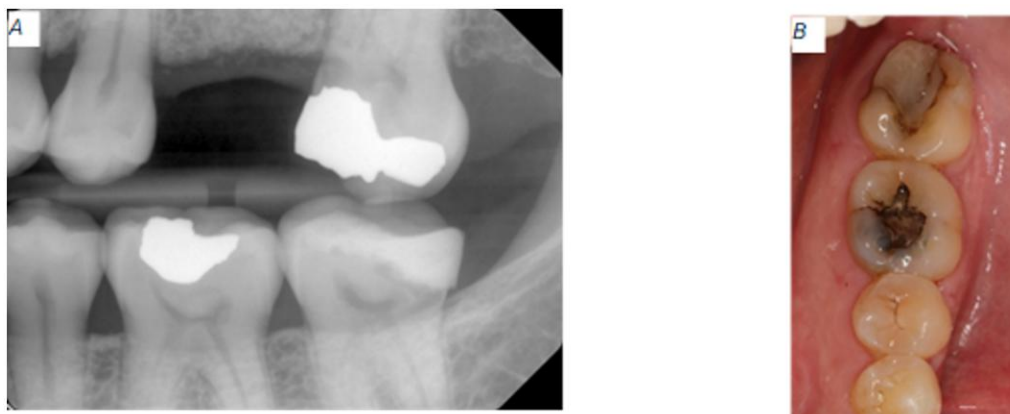
**Figure 2:** Baseline radiographic and clinical appearance for tooth #18. (A) Excess restorative material nearing the alveolar bone. (B) Recurrent caries around the composite restoration.

Concerning the mandibular left side, tooth #18 presented with recurrent caries around a composite restoration that replaced the distolingual cusp. The distal margin of this composite projects apically beyond the cavity preparation and appeared to approach the crestal bone (**Fig 2**).

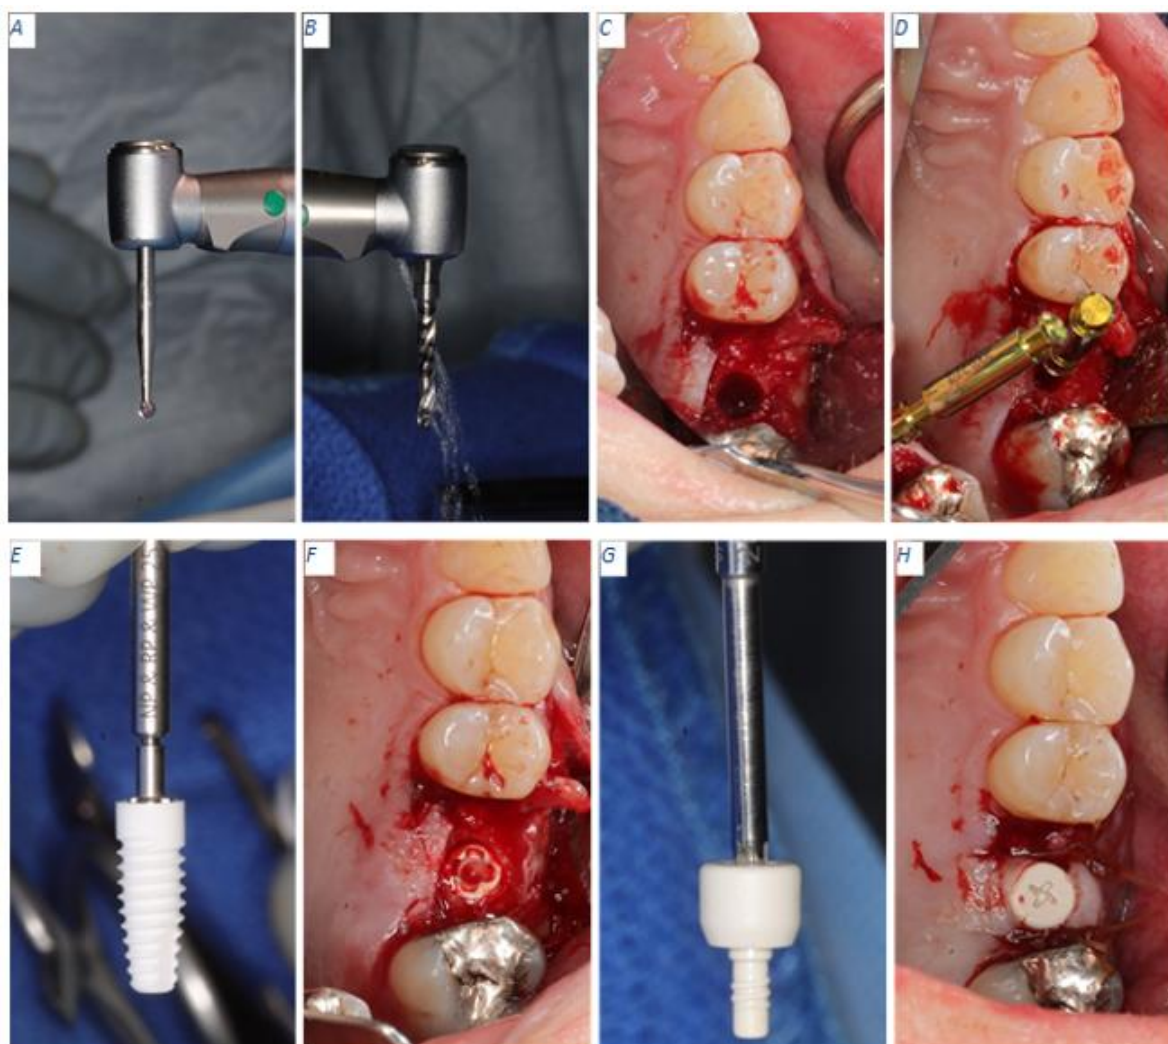
**Figure 3:** Implant placement workflow. (A) NobelPearl Round Bur 2 mm used to create an initial pilot hole for freehand implant placement protocol. (B) NobelPearl Tapered Twist Drill 2.3 mm running at a maximum of 800 rpm to form the initial osteotomy. (C) Final osteotomy completed with the NobelPearl Tapered Drill RP 4.2 x 10 mm running at a maximum of 600 rpm. (D) NobelPearl 4.2 mm Depth/Direction indicator in place. (E) Implant placement with NobelPearl Implant Driver Inter-X. (F) NobelPearl Implant in osteotomy at crestal level. (G) NobelPearl Healing Abutment ready for insertion using the NobelPearl Screwdriver. (H) Healing abutment torqued to 5 N·cm.

In the OR on the day of surgery, the surgical team performed a FCLP for tooth #18 and placed a NobelPearl implant at site #14. For the implant placement, we elevated a full mucoperiosteal flap extending from tooth #13 to tooth #15. Sequential osteotomy was done using the NobelPearl Round Bur 2 mm, Tapered Twist Drill 2.3 mm, Tapered Drill NP 3.5 x 10 mm, Tapered Drill RP 4.2 x 10 mm, and Screw Tap RP 4.2 mm. A NobelPearl Tapered 4.2 x 10 mm RP implant was placed at a crestal level using the NobelPearl Implant Driver Inter-X at a speed of 15 revolutions per minute (rpm). The implant was tightened with the manual torque wrench to 30 Newtons-centimeters (N·cm) (**Fig 3**). A NobelPearl Polyetheretherketone (PEEK) Healing Abutment was placed on the implant and torqued to 5 N·cm. All the implant placement steps, tooling, speeds, torque, and irrigation requirements were followed as depicted in the NobelPearl™ procedures manual and instructions for use (IFU) [6,7].

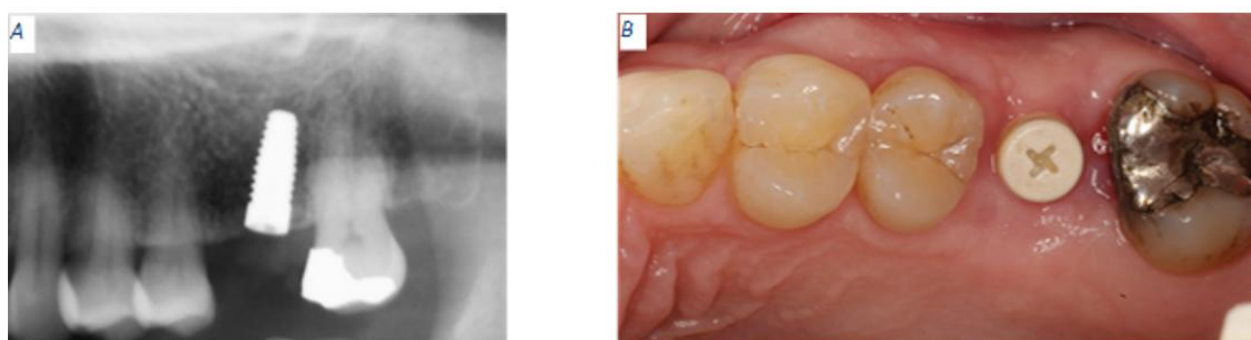
**Figure 4:** Two weeks post operation. (A) PEEK abutment not visible in periapical radiograph. Implant appears to have a distal tilt. (B) Site #14 displays soft tissue healing within normal limits.

radiographically, everything was healing within normal limits and sutures remained intact. The tissues surrounding site #14 and tooth #18 were superficially debrided with a cotton tip applicator saturated with 0.12% chlorhexidine gluconate and the remaining gut sutures were removed. The patient received a post-operation brush to restart mechanical oral hygiene on and around the surgical sites (**Fig 4**).

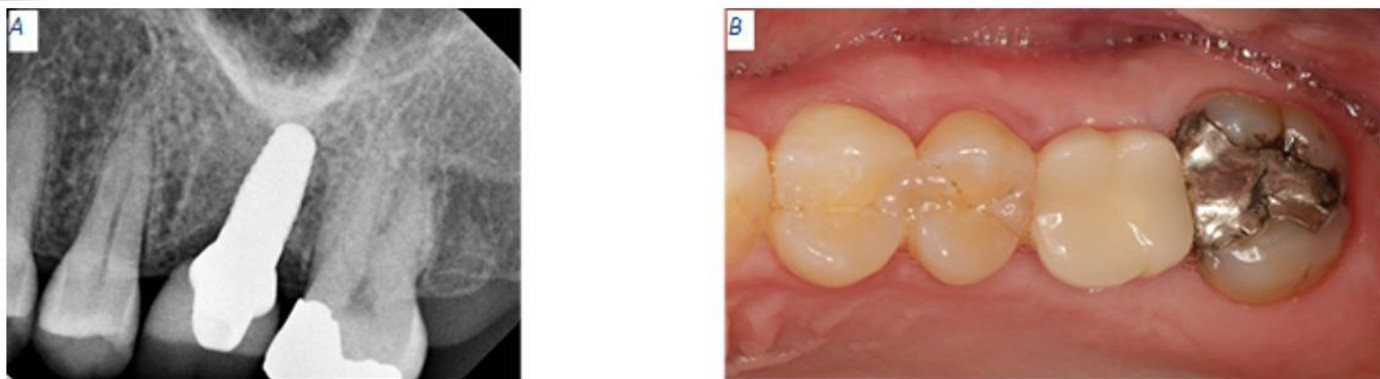
**Figure 5:** Six months post implantation. (A) Periapical radiograph showing final restoration. (B) IPS e.max crown after luting procedure.

At the six months appointment, the PEEK healing abutment was removed from the osseointegrated implant as site #14. A NobelPearl Straight Engaging Inter-X Prefabricated Zirconia Abutment was tried and torque to only 15 N·cm to allow for occlusal reduction until enough space was available for the final restoration. After abutment modification, the abutment was torqued to 25 N·cm using the Vicarbo NobelPearl Definitive Clinical Screw Inter-X (carbon-fiber reinforced PEEK). The access screw channel was obturated using Polytetrafluoroethylene (PTFE) tape. An IPS e.max crown was fabricated using the integrated CEREC Dental CAD/CAM System. The e.max crown was cemented using Rely-X Luting (resin modified glass ionomer cement). Excess luting cement was removed, and a verification periapical radiograph was obtained (**Fig 5**). Twelve days after the implant supported, cement retained restoration for site #14 was delivered, a flat plane, full arch, hard night guard was

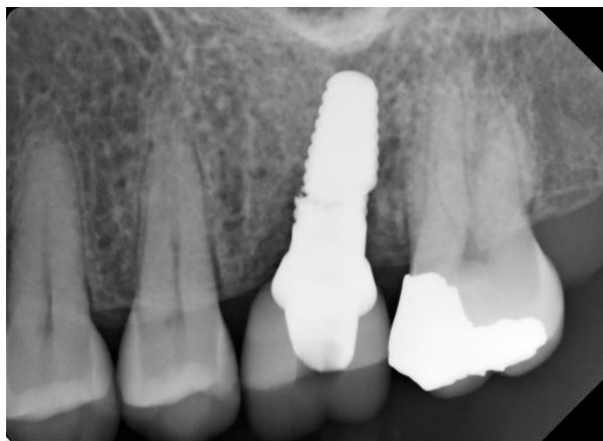
bleeding. Patient reports that a few weeks ago she heard a crunch while eating a breakfast sandwich but there was no apparent mobility or pain at that time. Intraoral evaluation reveals mobility of the implant crown. Periapical radiograph confirms a catastrophic implant fracture (**Fig 6**).

**Figure 6:** Abrupt fracture of zirconia implant.

the loose implant piece removed and receive a bone graft to cover the osseointegrated apical piece while at the same time reducing the chance of developing a major crestal ridge defect. The patient and the prosthodontist discussed the possibility of replacing missing tooth #14 with a three-unit FPD, but the patient refused this kind of treatment. A few days later, the patient returned to the dental clinic with the coronal portion of the fracture implant and the implant crown in her hand (**Fig 7**).

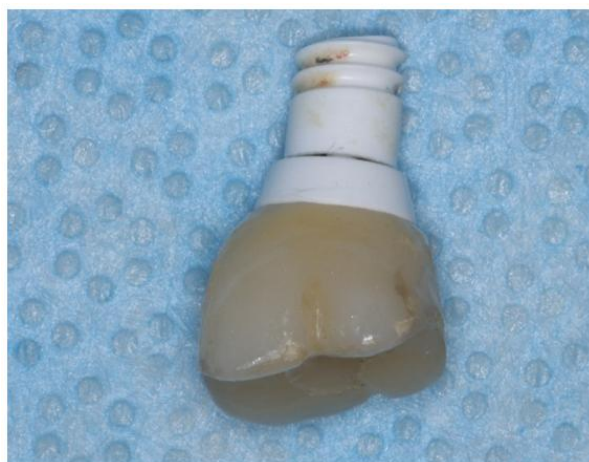
**Figure 7:** Patient retrieved piece of implant attached to crown.

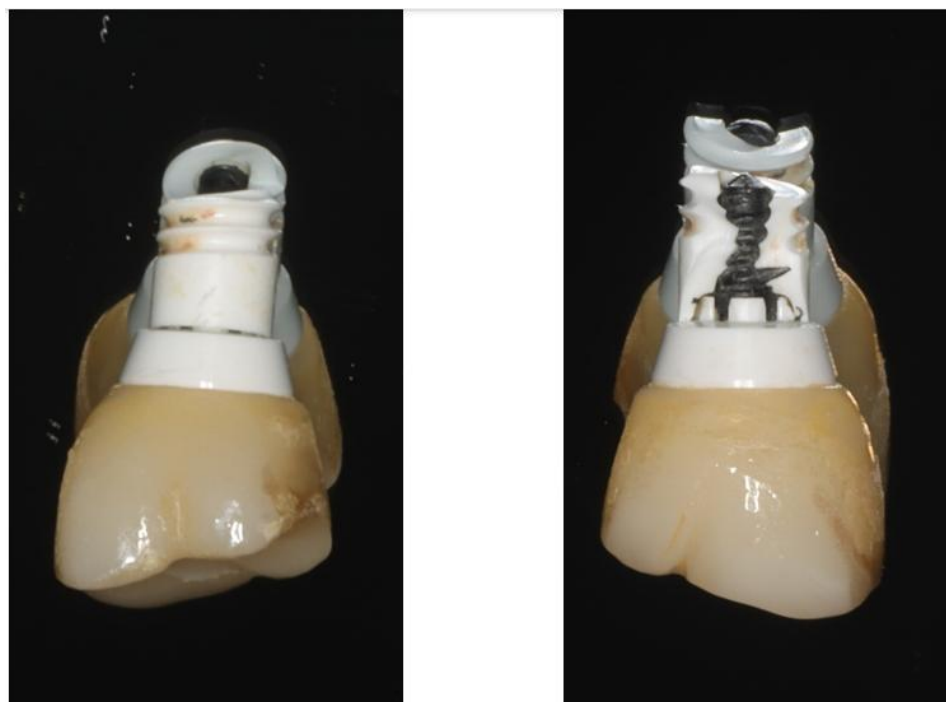
**Figure 8:** Internal-Implant connection fractographic behavior. (A) Implant fracture propagated radially between the 2<sup>nd</sup> and 3<sup>rd</sup> threads. (B) Vertical crack propagation exposed the Vicarbo screw and abutment.

In this case study, the implant most likely fractured due to a bending moment overload. A bending moment is produced when a transverse load is applied to a beam [20]. In other words the occlusal force provided a right-angle load to the implant through the implant restoration, while the implant acted as a beam which bent under the load. The bending overload concentrated internal stress points where cracks initiated and propagated until the implant fractured. In an article by Zhang et al., bending overload resulted in zirconia implant material stress in which one side of the implant presented in tension and the other side in compression.

Eventually, a crack formed on the tension side and propagated until a separation occurred [21]. The location and nature of the zirconia implant fracture vary depending on implant configuration, one-piece vs. two-piece. On the one hand, one-piece zirconia implants fractured at the endosseous portion between two threads. On the other hand, the two-piece zirconia implants can fracture in one of three fractographic behaviors; at the abutment neck, internal abutment-implant connection, or at the endosseous portion [21].

Regarding the implant featured in this article, the fracture happened at the base of the internal implant threads which receive the Nobel Pearl Vicarbo definitive clinical screw. The crack or cracks most likely had an internal origin but soon propagated radially between two implant threads and vertically towards the implant platform exposing the abutment. Based on this description and photos in **figure 8**, we can conclude that the implant failure fits the internal-implant connection fractographic behavior.
